# *UFZ Discussion Papers*

## **Sequential Disaster Forensics: An Application to Floods in the City of Grimma**

*Marina Mendoza, Reimund Schwarze*

November 2018

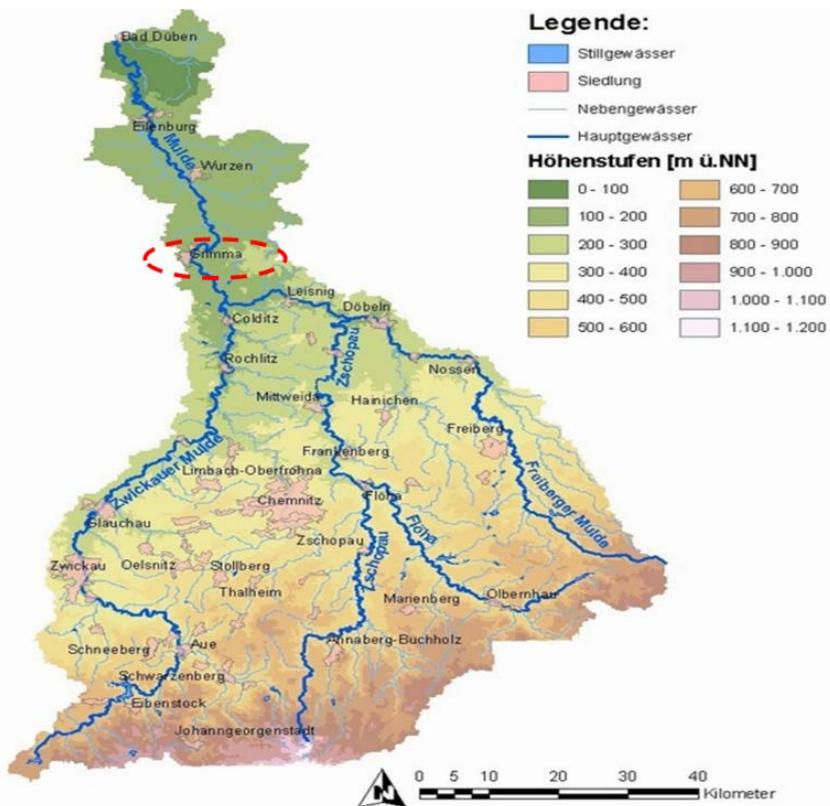
Figure 1 Mulde River catchment (Flood-ERA project)

The town of Grimma is located in the Free State of Saxony, Germany, on the western bank of the Mulde River (“Vereinigte Mulde” in German), 30 kilometres south of Leipzig. The Mulde River is a left tributary of the Elbe River, formed by the confluence of the rivers Zwickauer Mulde and Freiberger Mulde, with origins in the Ore Mountains (Figure 1).

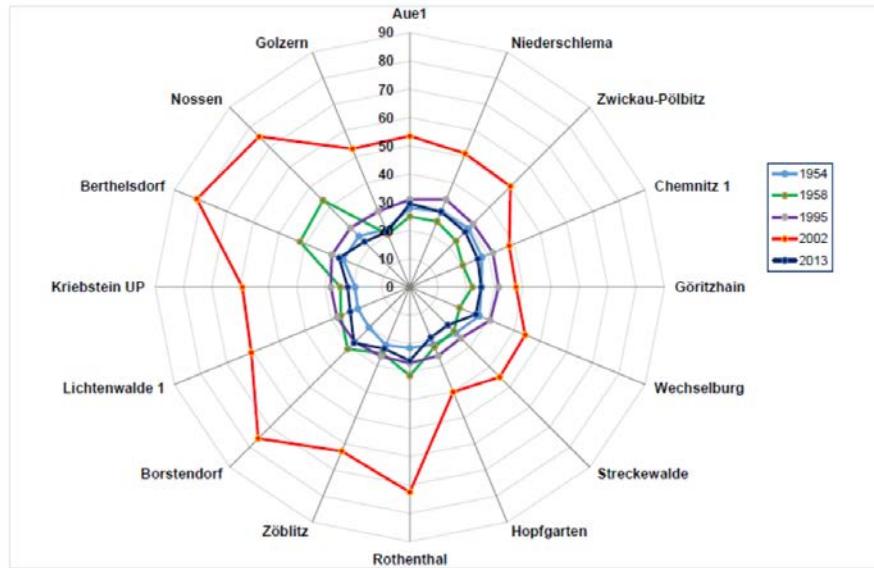
**Figure 8** 6-hour precipitation [mm] in pluviometers in Saxony in the Mulde catchment for historical events (Schumann et al., 2016)

Concerning precipitation, all the indicators (i.e. 6 hours, 12 hours, 24 hours and 48 hours maximum precipitations) show that the 2002 event was much more severe than the event of 2013. Furthermore, when compared to other important historical events, the precipitation in the 2002 flood always stands out, in all the pluviometers of the Mulde catchment in the Saxony State, for all the indicators and historical events. An example is provided in Figure 20 for the 6-hours maximum precipitation (the 12-hours, 24-hours and 48-hours maximum precipitation provide similar graphs).

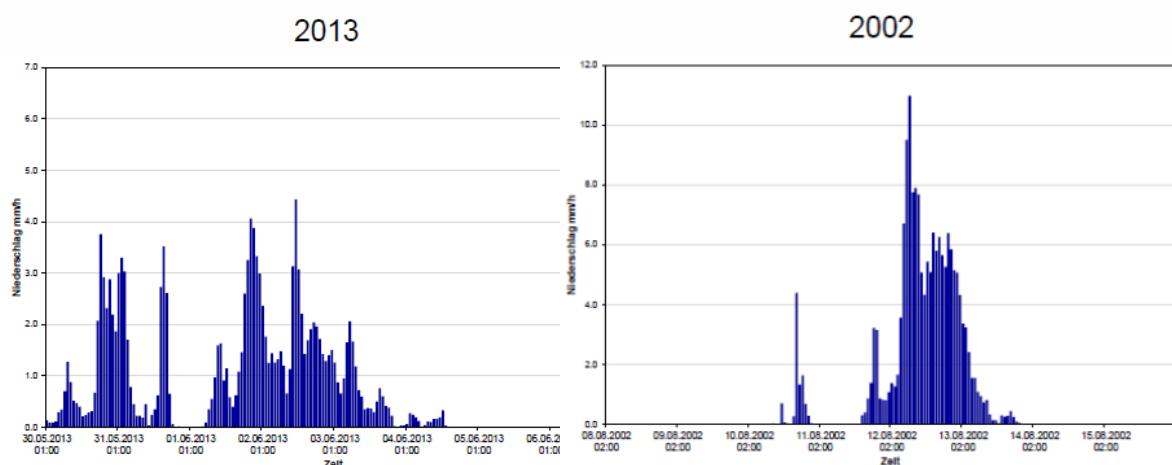
**Figure 9** Rainfall intensity [mm/h] in time for the 2013 and 2002 flood events in Pegel Bad Düben 1/Vereinigte Mulde gaging station (Schumann et al., 2016)

A further difference in the precipitation between the 2002 and 2013 events is found in the precipitation pattern. In 2013, rainfall can be divided into two-time sections (May 30, 05:00 to 31 May, 18:00 and June 1, 07:00 to 3 June, 8:00 pm), as seen in Figure 9 (Schumann et al., 2016). Consequently, runoff increased until late hours of May 31<sup>st</sup>, with a temporary drop in the amount of rainfall, and then started to increase again, stronger and more prolonged than before, when rain resumed in the morning of June 1<sup>st</sup> and lasted until June 2<sup>nd</sup> and 3<sup>rd</sup>, depending on the location within the catchment.

In 2002, beginning in the afternoon hours of August 10, it rained an average of 11mm into the night hours (around 22:00). In individual areas, significantly higher rainfall values were recorded (e.g. Stollberg 45 mm and Eibenstock 25 mm) (Schumann et al., 2016). Overall, this precipitation was followed by a precipitation-free period, which lasted until the late afternoon hours of August 11. After that, intensive precipitation continued until the early morning hours of August 13. Between August 11, 17:00 and August 13, 20:00 hours, around 120 to 300 mm of rain fell in the river basin, depending on location.

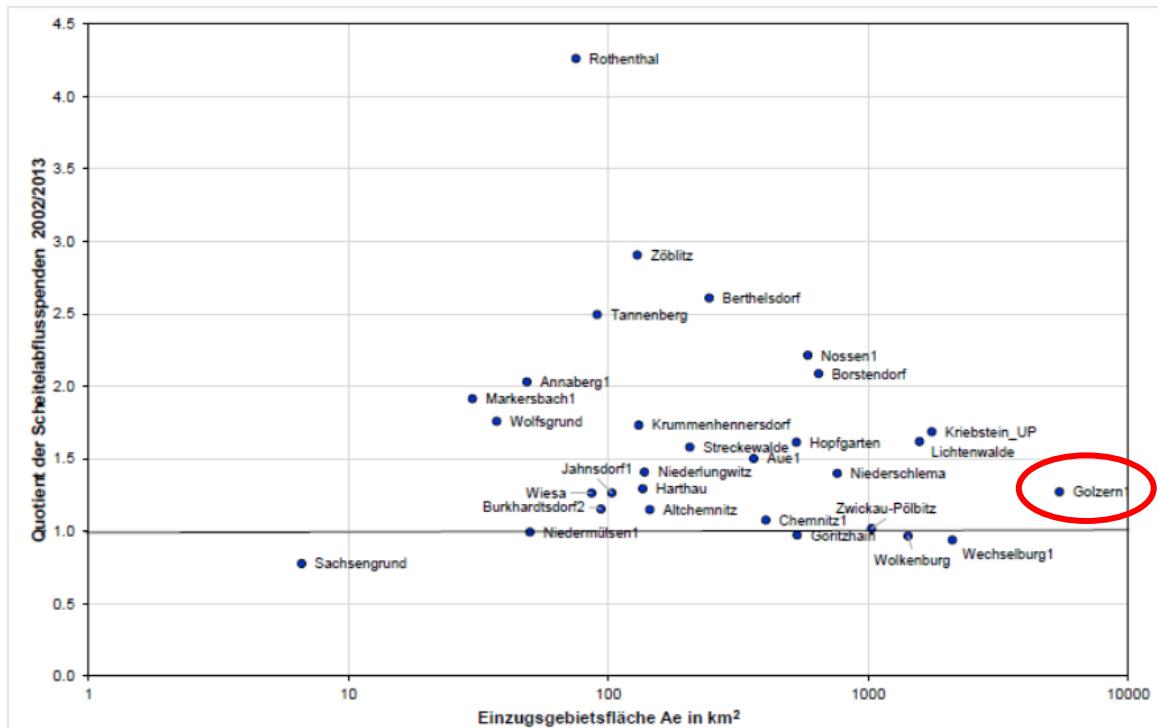
**Figure 10** Ratio of peak discharge in 2002 and 2013 in different gaging stations (Schumann et al., 2016)

In addition, another indicator that was selected for the comparison was the peak discharge in the same gaging station, Golzern 1. In 2002, the peak discharge measured in Golzern 1 was  $2600 \text{ m}^3/\text{s}$ , while in 2013,  $2040 \text{ m}^3/\text{s}$ . Figure 23 shows the peak discharge ratios of 2002 and 2013 for all the gaging stations in Saxony. It is possible to see that in almost all cases the peak discharge in 2002 was bigger than the one of 2013, with a ratio that varies from 0.6 to 4.3.

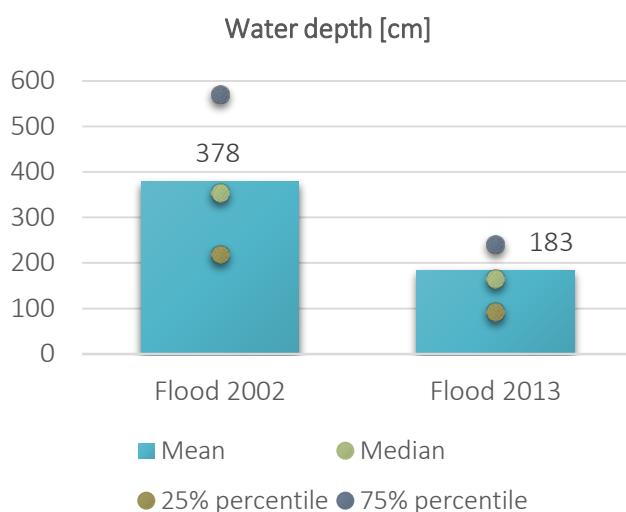
**Figure 11** Water depth [cm] in 2002 and 2013 floods

Available data regarding water depth corresponds to the data collected at a household level, through computer aided telephone interviews with residents, from the flood loss data of private households from University of Potsdam, German Research Centre for Geosciences and Deutsche Rückversicherung. Different statistics were calculated from the samples, i.e. statistical mean, median, 25<sup>th</sup> and 75<sup>th</sup> percentile, all represented in Figure 11. It is possible to note that even if there is more dispersion in the 2002 values, there is a clear upward shift of the 2002 values with respect to 2013 and, thus, the statistical mean is a good indicator for comparing both events.

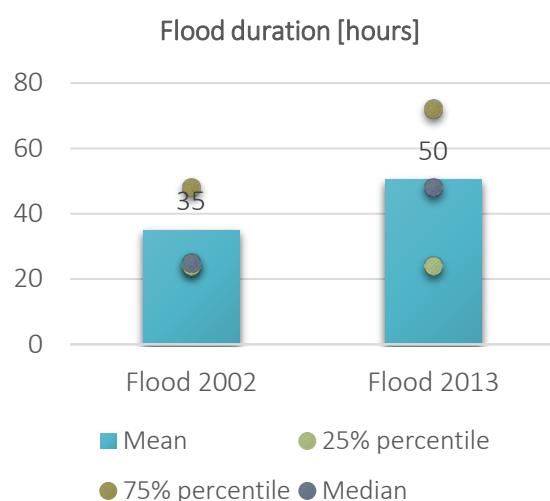
**Figure 12** Flood duration [hours] at households for the 2002 and 2013 floods

Data from the questionnaires at household level also show the difference in flood duration (Figure 12), depicted by the mean values (35 hours in 2002 and 50 hours in 2013). The higher dispersion in the flood duration values of 2013 was also expected, given that the event actually consisted of two phases, which affects reporting.

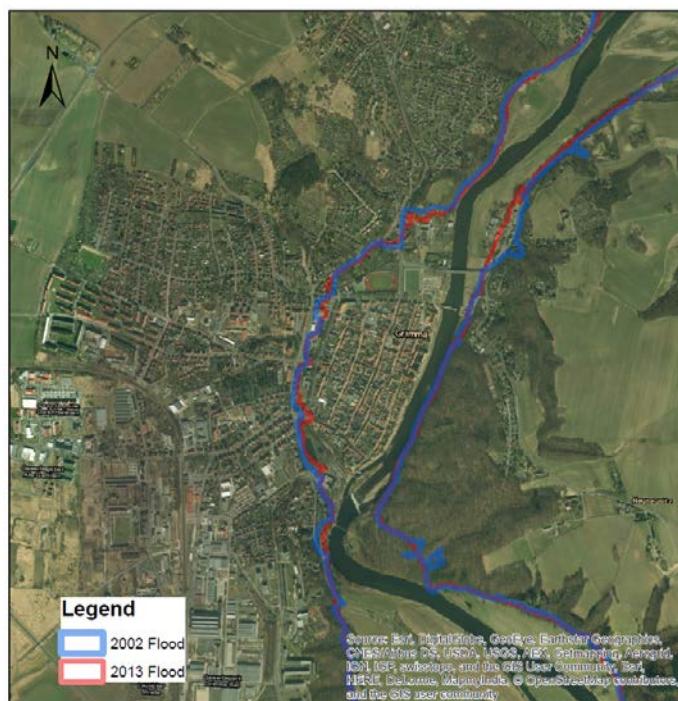
Figure 13 Map of the flooded areas in 2002 and 2013  
(elaborated with data from the Saxony State Office for Environment,  
Agriculture and Geology, 2017).

Flooded areas in 2002 and 2013 were almost coincident due to the topography of the area, where the town centre is around 15m below surrounding areas. Hazard maps from the Elbe Atlas of the Mulde River in the Grimma area show that the flood-prone area for floods of 100 year return period and above almost coincide. Likewise, the location of some affected households from the telephone interviews (not presented here due to privacy issues) corroborated this fact and so did direct observations during fieldwork, where some of the flooded buildings had plaques and marks that indicated the level reached by flood water. A map elaborated with data by the Saxony State Office for Environment, Agriculture and Geology (Figure 13) shows that the flooded area in 2002 is slightly bigger than in 2013 for the town of Grimma.

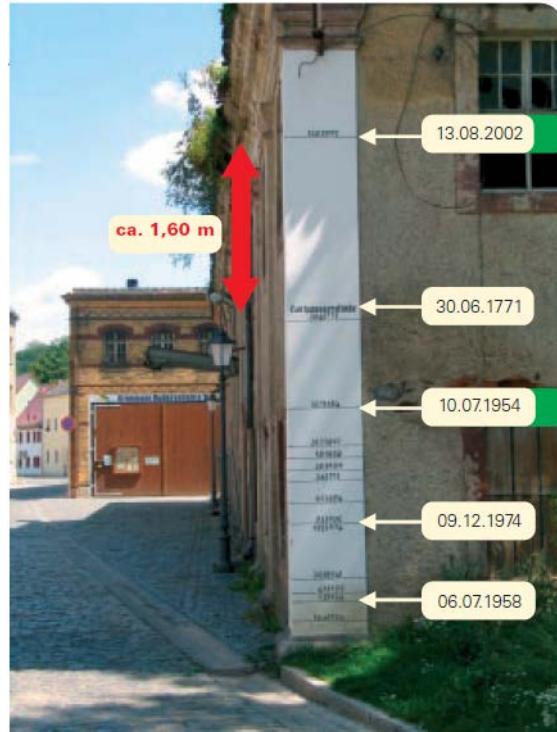
*Figure 14 Water level of historic floods,  
on the Großmühle building in Grimma centre  
(Landestalsperrenverwaltung des Freistaates Sachsen, 2006).*

Historical records show that heavy floods occurred in Grimma in the years 1573 and 1771, while minor floods were expected every 20 years (Siedschlag, 2010). The last major flood before 2002 happened in Grimma in 1954, but the water level was not comparable either to the 2002 nor the 2013 floods (Figure 14 and Figure 15).

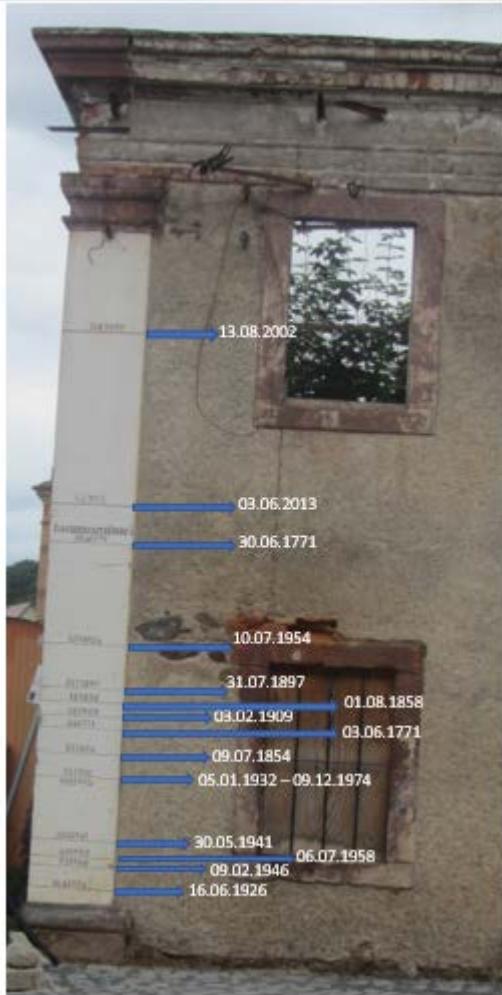
Figure 15 Historic flood levels in the Großmühle (large mill) in Grimma (2017, authors).

Flood year	1573	1771	1858	1897	1932	1954	1958	1974	1995	2002
Water level in the Mulde at Grimma [cm]	636	598	481	490	455	508	414	464	380	752

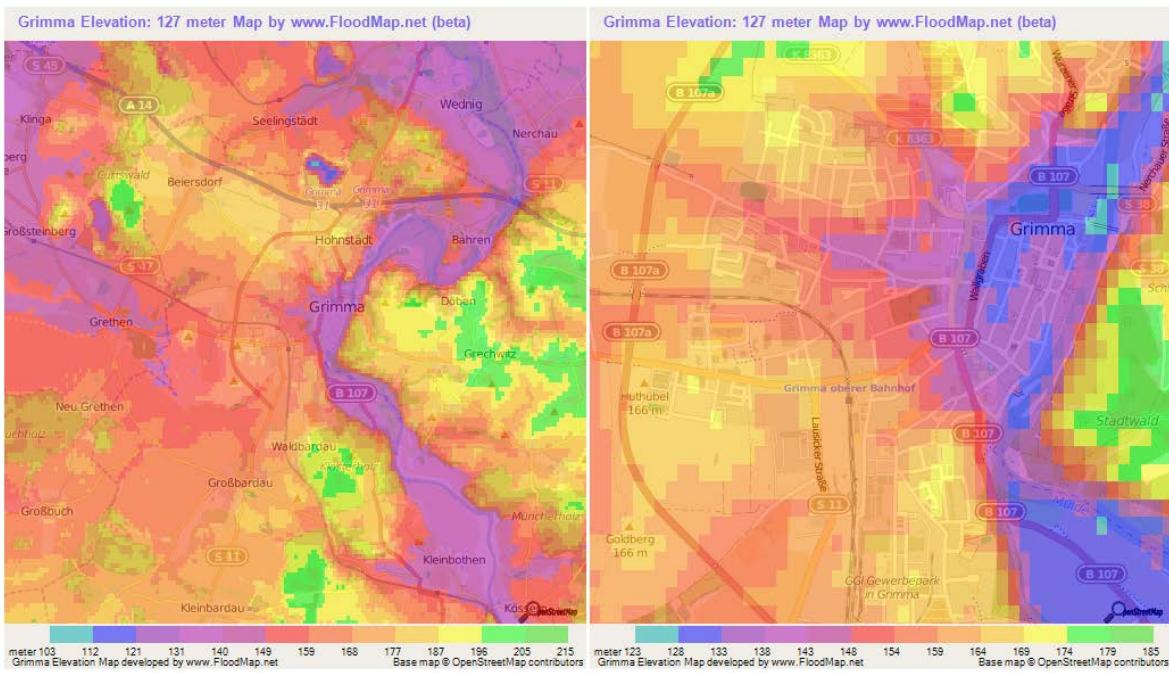
Figure 17 Elevation map of the town of Grimma. (Source: <http://www.floodmap.net/Elevation/ElevationMap/?gi=2917325>)

The town of Grimma is located in an area that is at a lower level with respect to the surrounding land, as shown in Figure 17. This explains why floods are always confined to the area of the city centre.

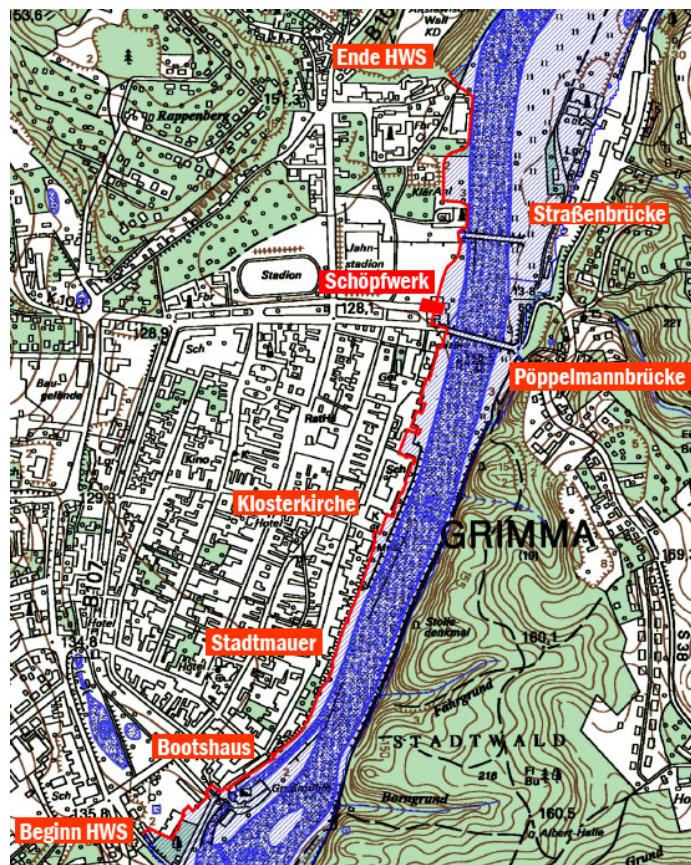
Figure 25 Flood wall projects for the town of Grimma (hochwasserschutz-grimma.de, 2017)

- Project 1 – From the street "Kellerhäuser" to the north end of the boathouse.
- Project 2 - Old City Wall from the boathouse (Bootshaus) to the monastery church (Klosterkirche).
- Project 3 - Klosterkirche to Pöppelmann Bridge.
- Project 4 - Pöppelmann bridge to the end of the natural rock massif.
- Project 5 - Sealing wall and subsoil seal.

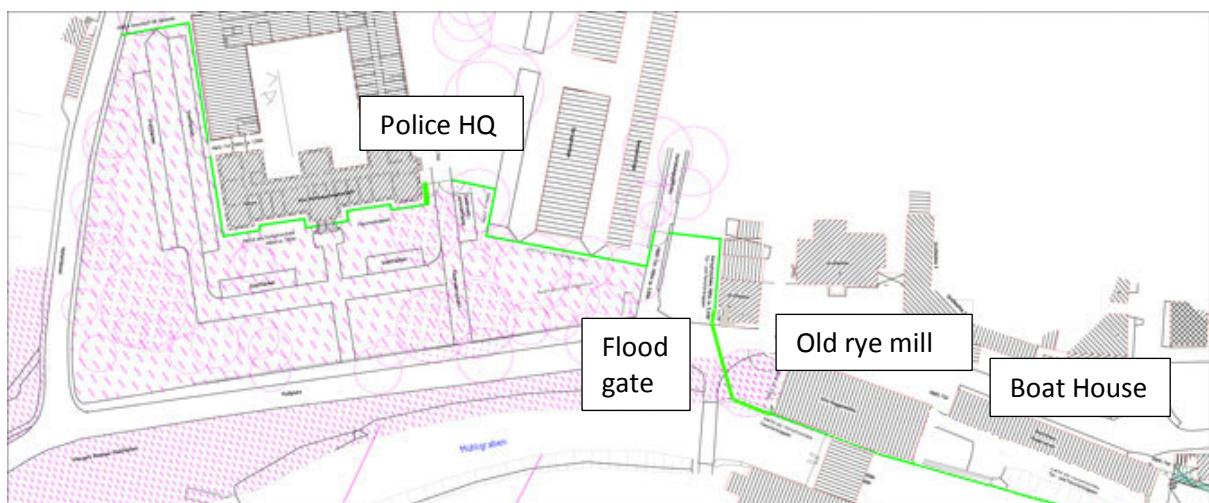
**Figure 26** Project 1, floodwall (hochwasserschutz-grimma.de)

Project 1 (Figure 26) includes the area from the street "Kellerhäuser" to the north end of the boathouse. The police station buildings, the new garages, a restaurant, the old rye mill and the boathouse will be surrounded by the walls. The short sections between the buildings are protected by free-standing walls. The height of the wall varies between 1.5 m (new police building) and about 4 m (rye mill/ boathouse) (hochwasserschutz-grimma.de, 2017). The historic building that is part of the police new Headquarters, built around 1900, will be integrated into the flood protection scheme and, thus, floodproofed. Another important element of Project 1 is the floodgate, next to the old rye mill (Figure 27).

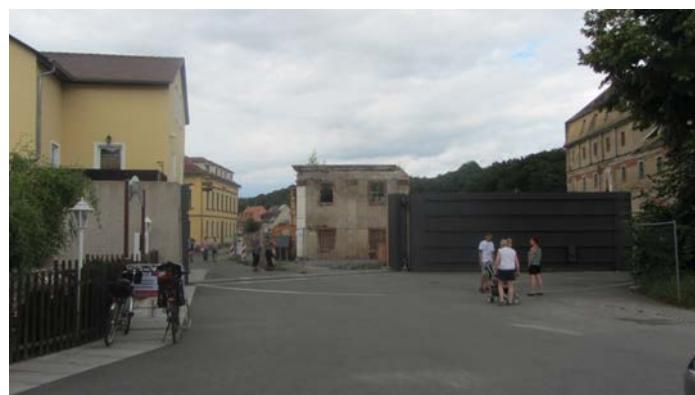
**Figure 27** Floodgate, part of the floodwall Project 1

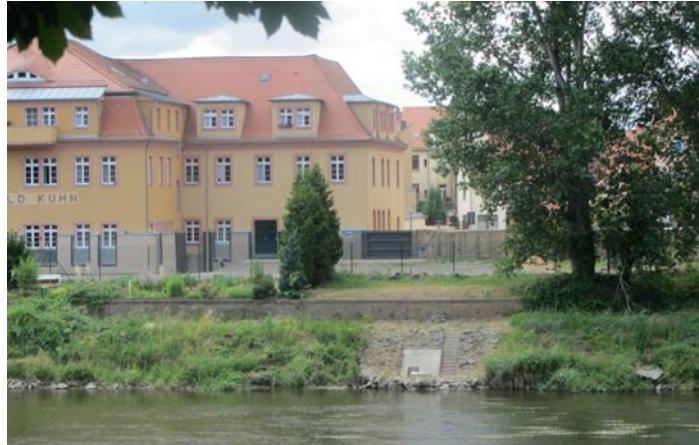
**Figure 3** New floodwall, part of Project 2, with passageways for accessing the river and allowing a view (2017, authors) short notice in case of imminent floods (hochwasserschutz-grimma.de, 2017).

In Project 2, the old city wall from the boathouse to the monastery church, the new wall was erected directly in front of the existing city wall. The height of the floodwall varies between 3.5 m and 4.5 m. Three passageways were left on the wall to guarantee access to the river (Figure 40). All three passages are equipped with a high-water protection gate on the waterside so that the waterways can be closed at

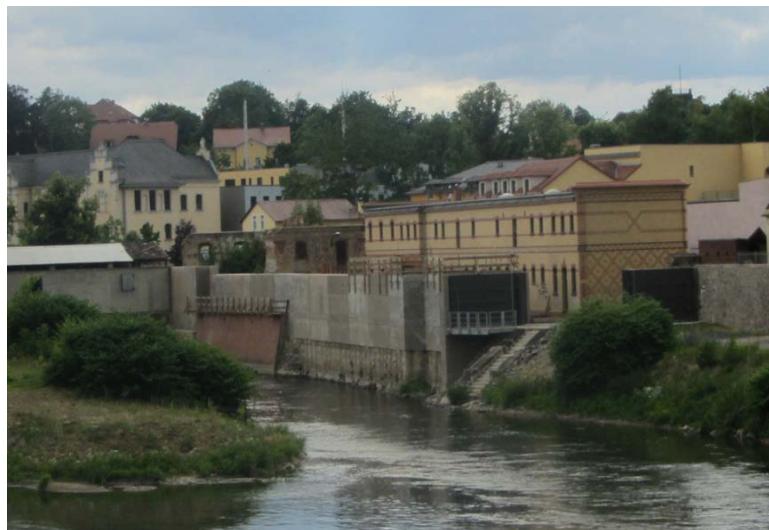
**Figure 4** Floodwall, Project 2, under construction (June 2017, authors). Project 3 covers the area between Klosterkirche (Monastery church) and Pöppelmann bridge (Figure 30). In this case, the layout takes into account the buildings.

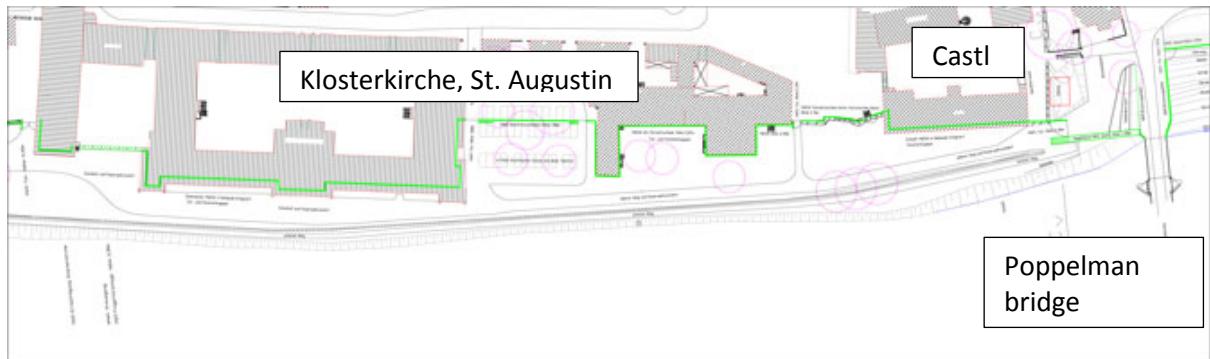
**Figure 30** Project 3 layout ([hochwasserschutz-grimma.de](http://hochwasserschutz-grimma.de))

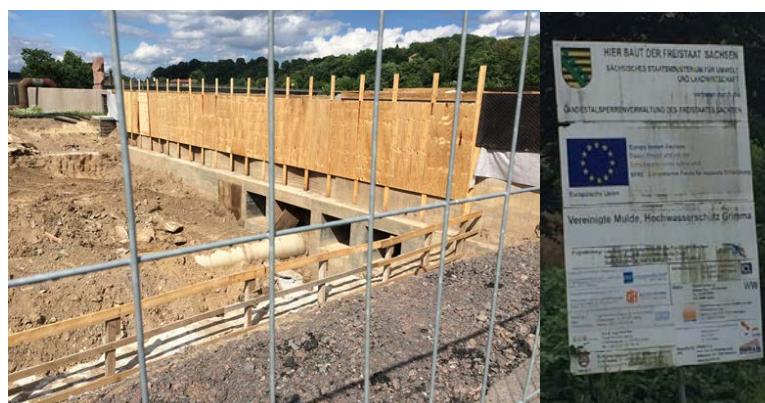
**Figure 31** Floodwall, project 4, under construction (June 2017)

Project 4 begins at the Pöppelmann Bridge and leads to the end of the natural rock massif north of Grimma. A freestanding reinforced concrete wall is envisaged; on the north side of the Pöppelmannbrücke, the protection system runs inland to the foot of the bridge and then swings to the North to meet the new Mulde bridge in a line that is curved towards the river. The height of the flood protection system varies between 2,5 m and 3 m (hochwasserschutz-grimma.de, 2017). This project is still under construction (as to June 2017) and is expected to be finished by 2018 (LVZ, 2016) (Figure 31).

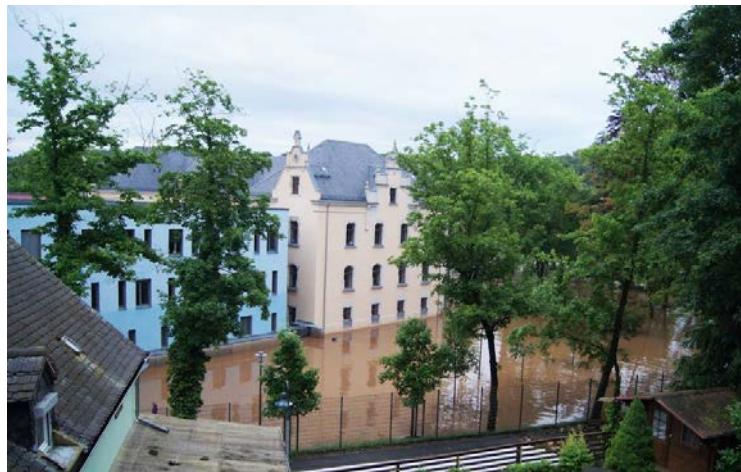
*Figure 34 New police station flooded during the 2013 flood  
(Colditzer-tageblatt online newspaper, 2013)*

The 2013 flood caused damages of around 150 million euros in Grimma, with about 650 buildings damaged (Grimma Municipality, 2017). These included two schools, one music school, a kindergarten, the city hall, the district court and the new police station (Figure 34).

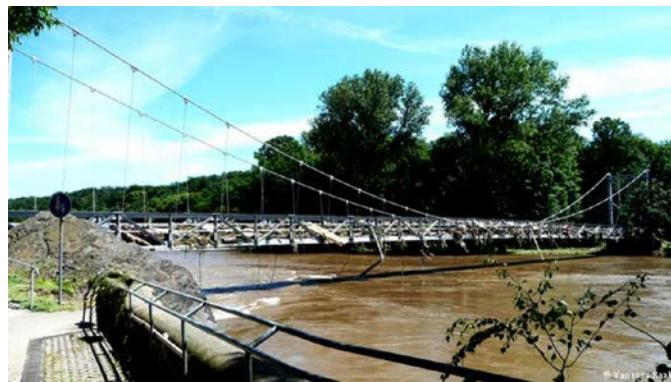
**Figure 35** Suspension bridge covered in debris  
on June 6th 2013 (DW, 2013)

The suspension bridge over the Mulde river was covered with flotsam and unpassable, though it was not damaged (Figure 35).

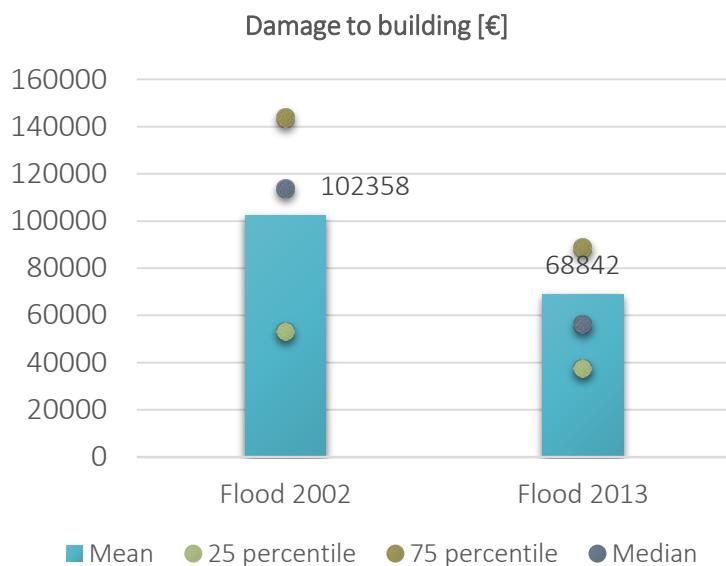
**Figure 36** Damage to buildings (corrected for inflation to 2013)  
within the samples for the 2002 and 2013 floods

As it would be expected, considering that the water depth was higher during the 2002 flood, as analysed in a previous section, damage to the building statistics of 2002 are higher than those of 2013. Nevertheless, damage to household contents does not follow the same trend (Figure 37). The fact that damage to contents is very similar in both events could be explained by the important difference in flood duration.

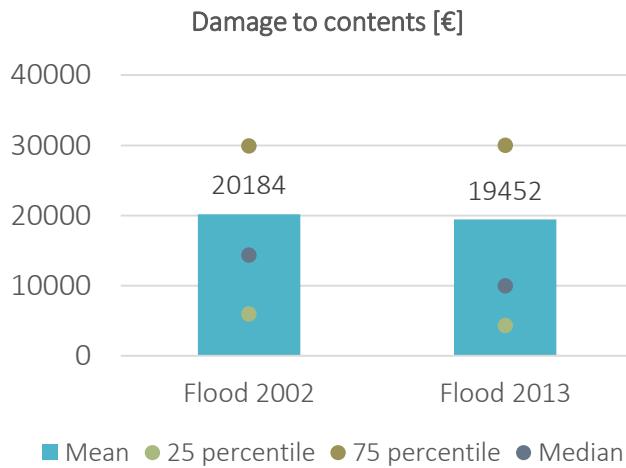
**Figure 5** Damage to household contents (corrected for inflation to 2013) within the samples in 2002 and 2013 floods.

In order to rule out other factors that could have determined a similar damage to contents during the 2013 flood event with respect to 2002, different hypotheses were generated and analysed, following the phases of accident investigation (ESReDA, 2009). These hypotheses were generated by the authorstabl based on the knowledge on flood damage mechanisms.

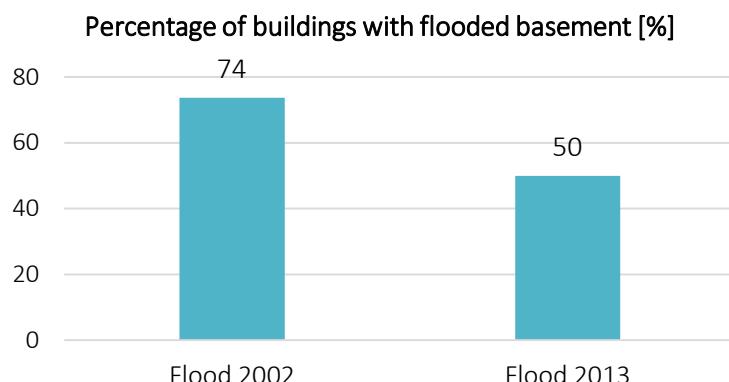
**Figure 38** Percentage of buildings within the sample with flooded basements in the 2002 and 2013 floods

The first hypothesis or assumption to be tested is that in 2013 there were more buildings in the sample with a flooded basement. If this were the case, then basements would be flooded, and their contents damaged, which would add to the total damage to contents, even with a lower water depth.

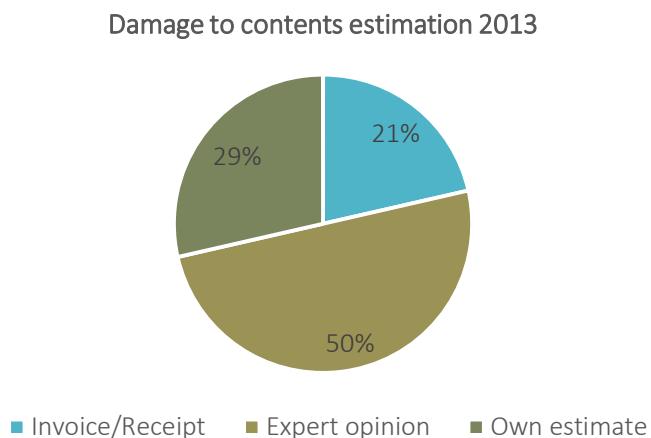
**Figure 39** Damage to contents estimation for the 2013 flood event

Damage to contents is expressed in monetary values and used directly as it is to compare the impacts of the 2002 and 2013 flood events. However, this monetary value could represent different things. Damages can be expressed as costs of replacement or repair, depending on whether the item was replaced or repaired, due to the degree of damage of the item, type of item, the possibility of repair, cost of repair vs. replacement, etc. Furthermore, the estimate of these costs can vary depending on whether the item was already replaced/repaired, so the effective cost is known or if it is an estimate for future repair/replacement. At the same time, this estimation can be different if done by an expert or by the affected citizen. Unfortunately, this information is only available for the 2013 questionnaire, where a question was added regarding the type of estimation of damages to contents. Possible answers include: “invoice/receipt”, “compensation/insurance expert opinion”, “own estimate”. Results show for 2013 that in half of the cases the estimation was done by an expert, while 29% of the residents estimated the damages themselves (Figure 39). This could have influenced the number of damages reported. However, without the 2002 data, it is difficult to conclude.

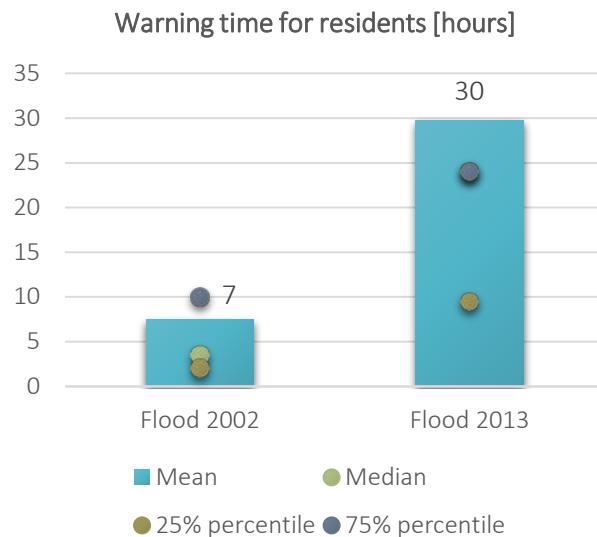
**Figure 40** Warning time for residents within the samples [hours]

In 2002, no timely flood warning was received in Grimma (Schanze et al., 2008). Data from the interviews at the household level (from University of Potsdam, German Research Centre for Geosciences and Deutsche Rückversicherung) show that the mean warning time that the residents had during the 2013 flood event was more than 4 times the one from the 2002 flood event (Figure 40). Other statistics such as the median and the mode also support this difference (Table 9).

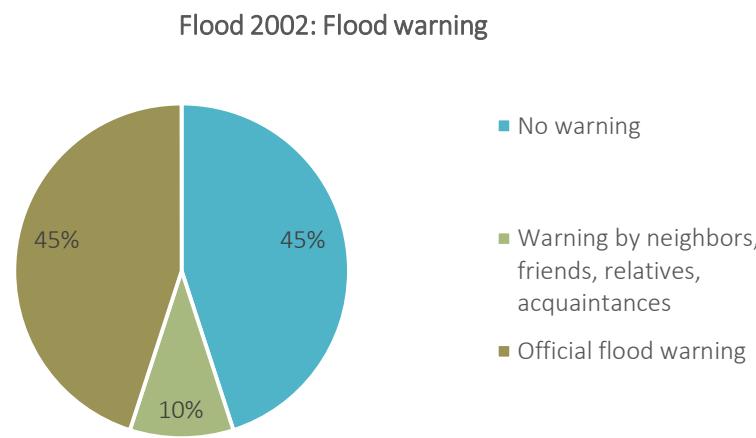
**Figure 41** Flood warning distribution in households' data in the 2002 flood

The analysis of the data at the household level (Figure 41) shows that in 2002, 45% of the households of the sample did not receive any kind of flood warning. Moreover, only 45% was warned by official sources. Instead, in 2013 (Figure 42) only 17% of the households in the sample did not receive any flood warning, while 78% received official warnings.

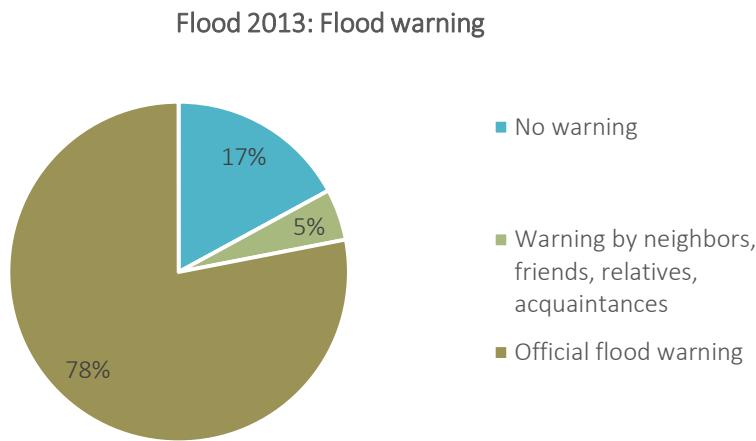
**Figure 42** Flood warning distribution in households' data in the 2013 flood
